# Multi-Sensor Inspection for [YOUR CUSTOMER]

06000000040M\_TMP90782M

Highway 35, Dallas, TX

[YOUR PROJECT NAME]

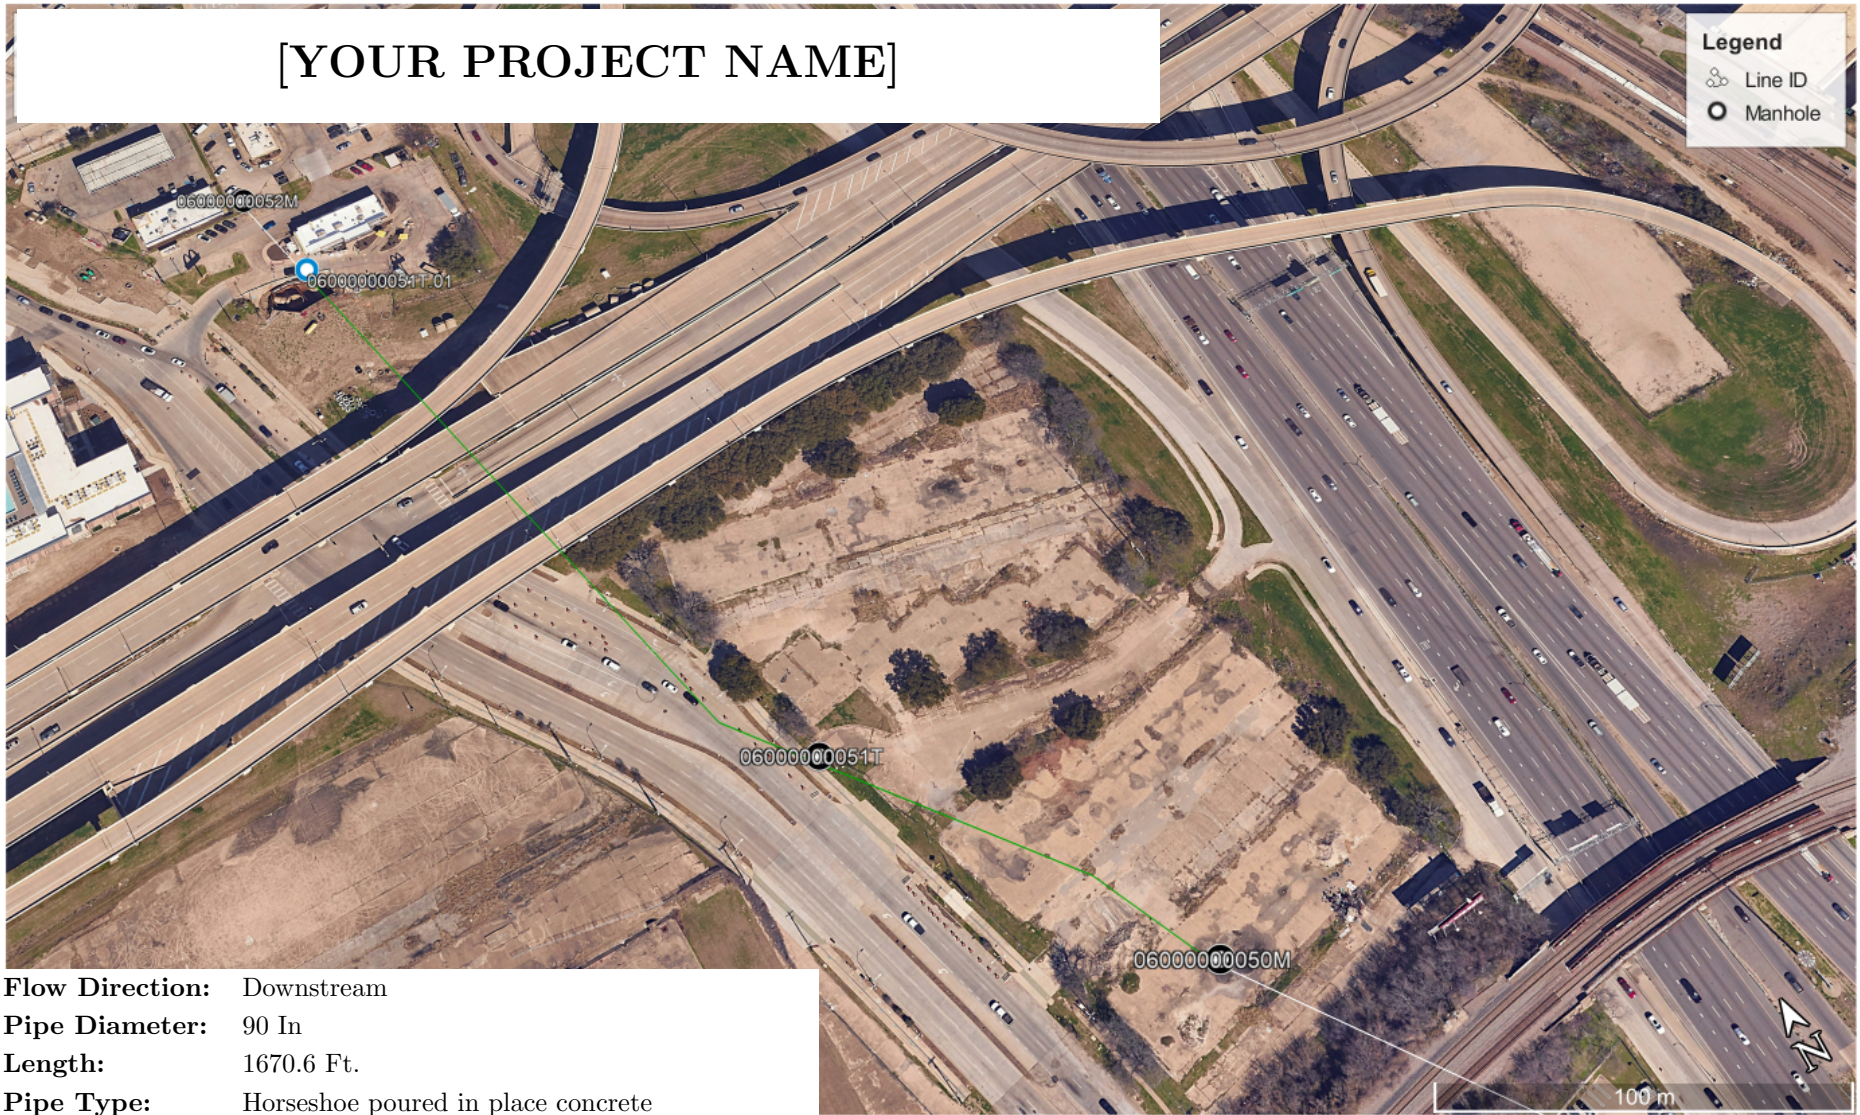
**Flow Direction:** Downstream  
**Pipe Diameter:** 90 In  
**Length:** 1670.6 Ft.  
**Pipe Type:** Horseshoe poured in place concrete

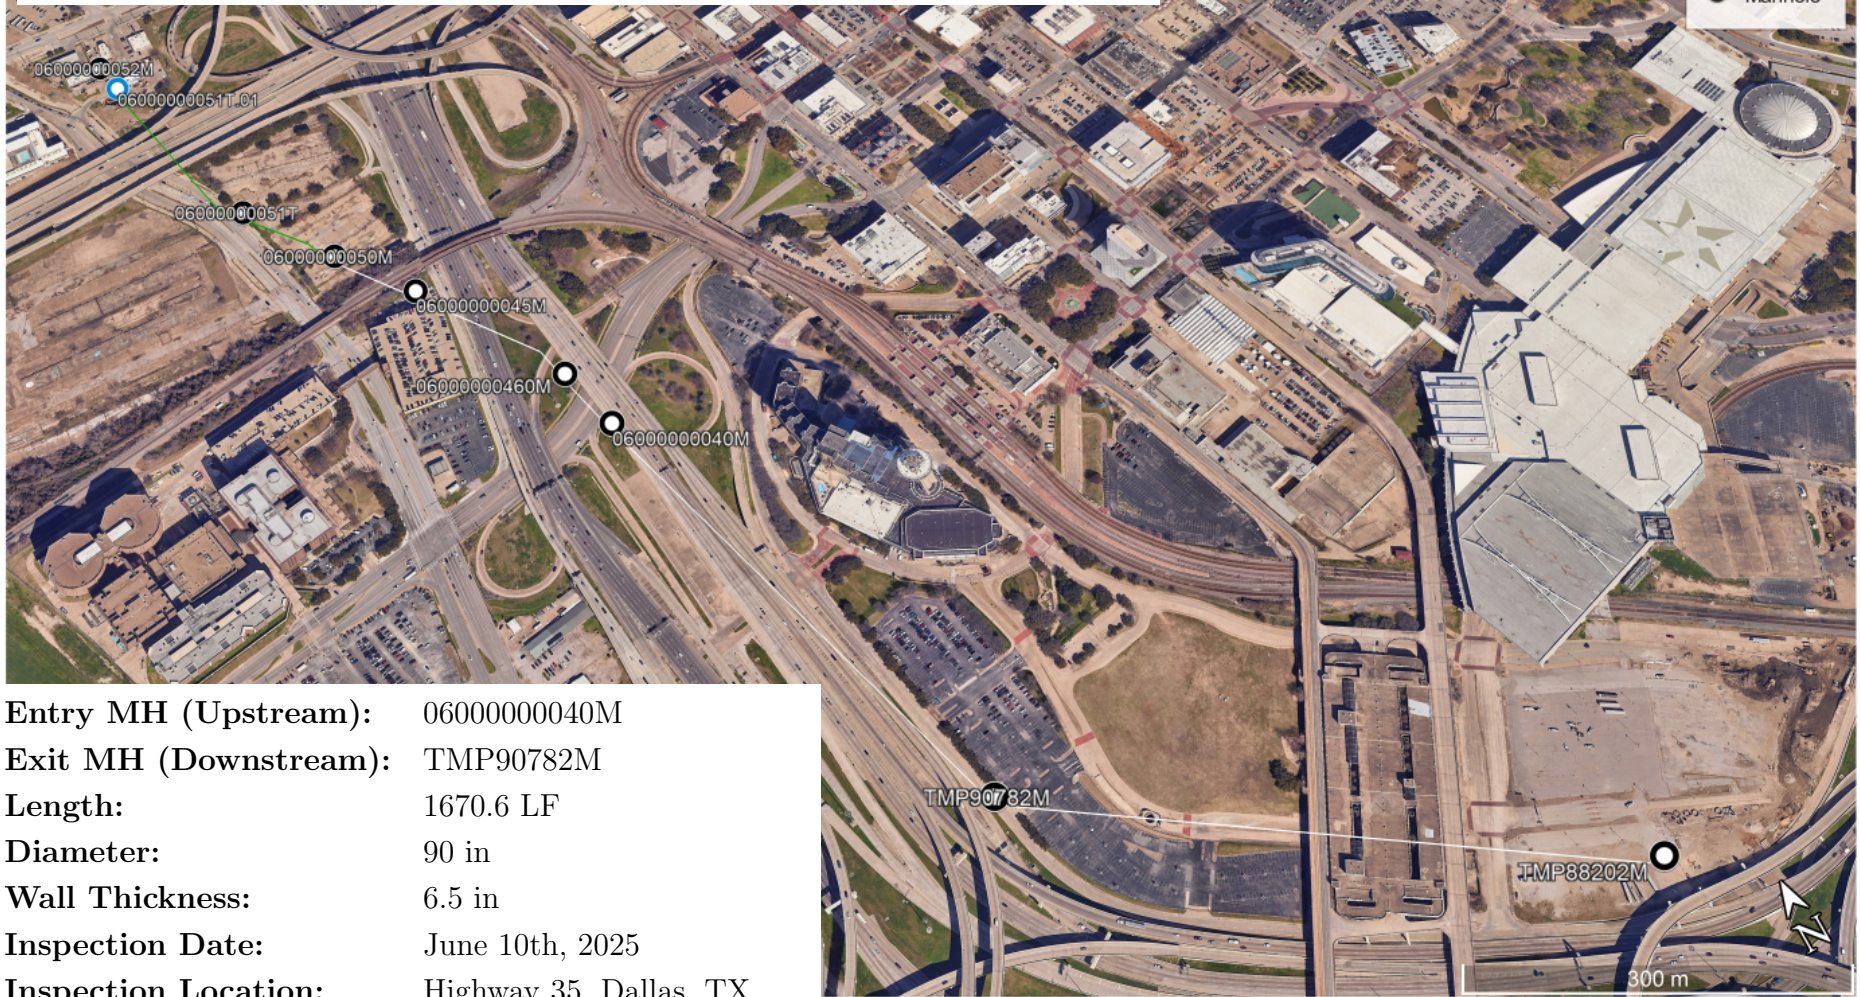
Map Layout

Entry MH (Upstream): 06000000040M  
Exit MH (Downstream): TMP90782M  
Length: 1670.6 LF  
Diameter: 90 in  
Wall Thickness: 6.5 in  
Inspection Date: June 10th, 2025  
Inspection Location: Highway 35, Dallas, TX
